BD Loops

1/8" Groove Test

Observations of 1/8" saw-cut grooves and how well they are sealed in asphalt or concrete

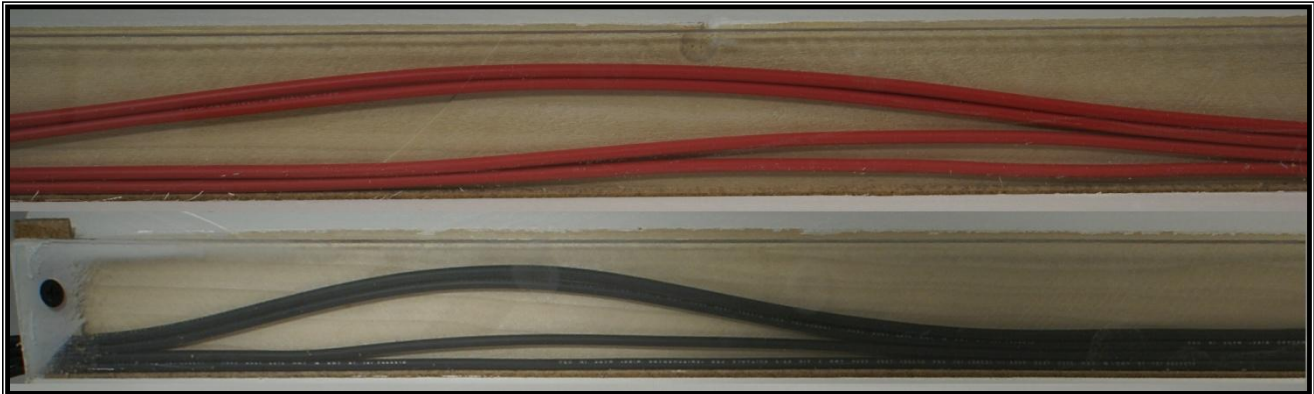
Figure 1

Picture of 1/8" Plexiglas groove with Brand Y's and Brand X's 1/8" groove approved wire inside before loop sealant is applied.

was recorded (see Results section). 3 conductors of Brand Y loop wire were laid into 2 different Plexiglas $\frac{1}{8}$ " groove bases (.125 and .122). 4 conductors of Brand X loop wire were laid into 2 different Plexiglas $\frac{1}{8}$ " groove bases (.125 and .122) (see *Figure 1*). Each base was then given a special label (Chemque Q-seal 290S Loop Sealant and Bondo P-606V Epoxy) to insure the proper sealant is used for each groove and that each wire gets tested with the correct type of sealant or epoxy. Each $\frac{1}{8}$ " Plexiglas groove was covered with tape so that the assistant could not see the inside wires. Sealant was applied to each $\frac{1}{8}$ " Plexiglas groove making sure to completely seal/fill the groove by making several passes. The $\frac{1}{8}$ " Plexiglas grooves were then covered and allowed time to harden overnight. Covering and tape were removed and the results were documented and pictured.

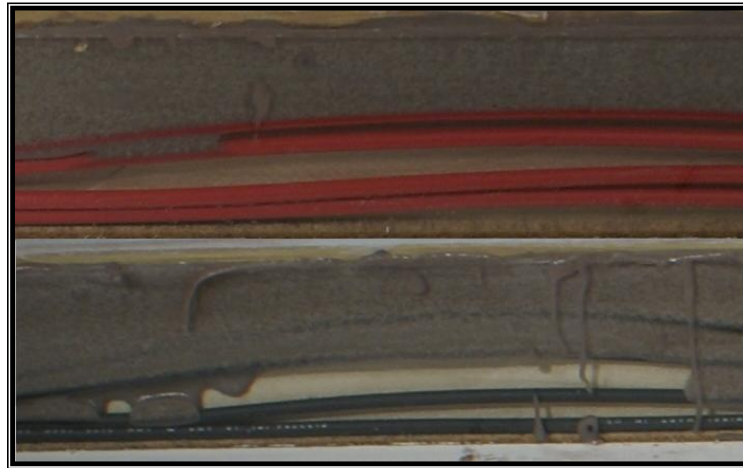
Figure 2

Picture of air-pocket after sealant has been applied

Results show regardless of the viscosity and type of sealant used that a 1/8" saw-cut groove will not fully seal the wires, allowing space for an air-pocket (see *Figure 2*).

If a 1/8" saw-cut blade is used then the groove will not be completely sealed and air-pockets will be present which cause several intermittent loop problems.

Air pockets within the groove can cause a number of problems resulting in repeat service calls. Air pockets within the loop design allow space for the wires inside to move, when the wires move even slightly a false detection will occur. In colder temperatures air-pockets can cause even more problems by pushing the entire loop out of the saw-cut groove. This occurs when water enters the air-pocket and freezes. When water freezes it expands, that force will push the loop out of the groove completely. This then makes the loop susceptible to traffic and nature's wrath eventually causing the loop to short to ground (fail).

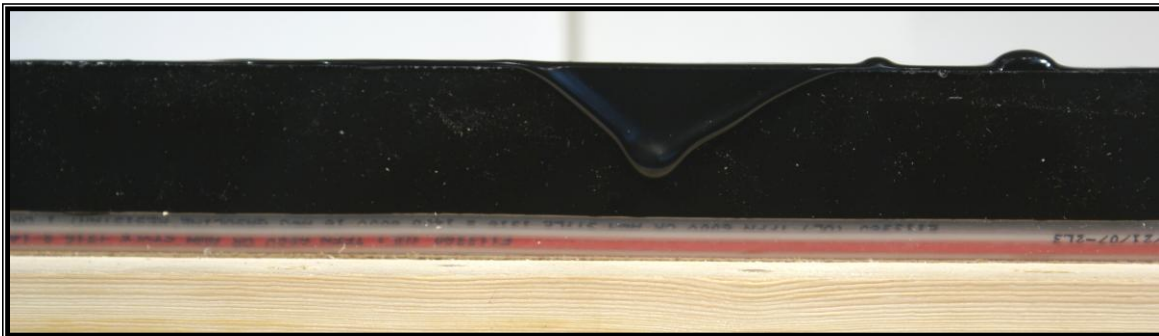
Figure 3

Picture of a BD Loops saw-cut in 1/8" Plexiglas with no air-pocket

Results show that installation of BD Loop's preformed loop will not allow air-pockets to form. (see figure 3)
